Manhole Inspection Summary

Manhole # S17QQ1028MH

Insp Date: **2/8/07 11:17 AM**

Location Address: **SPRINGGARDEN DR**

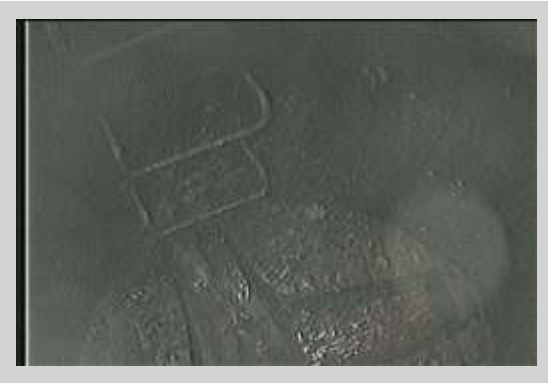
8 in. Circular Gravity Sewer Pipe Out @ 12 O'Clock

Rod and Bar (Angled)

Invert Depth: **24.80** (ft.) Flow Characteristics: **Slow**

Infiltration: **None** Pipe Seal Cond: **Unknown**

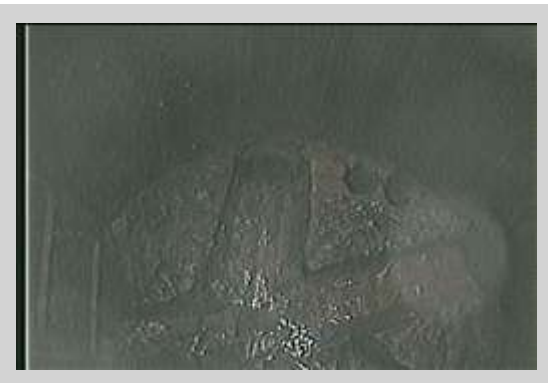
8 in. Circular Gravity Sewer Pipe In @ 3 O'Clock

Rod and Bar (Angled)

Invert Depth: **24.40** (ft.) Flow Characteristics: **Slow**

Infiltration: **None** Pipe Seal Cond: **Unknown**

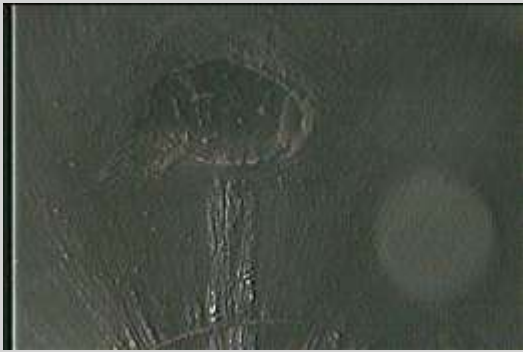
Pipe In @ 5 O'Clock

Invert Depth: **10.63** (ft.) Flow Characteristics: **Slow**

Infiltration: **None** Pipe Seal Cond: **Unknown**

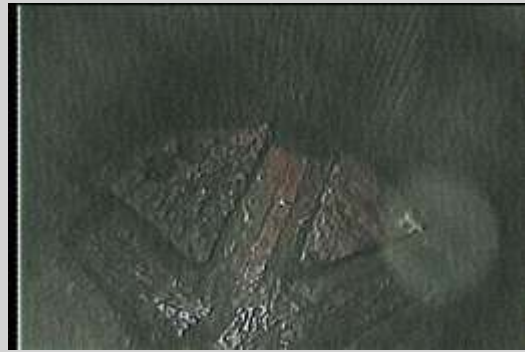
Drop In @ 5 O'Clock

Drop: **Outside** Rod and Bar
Angled: **Yes** Reading: **23.45** (ft.)
Inv Depth: **24.45** (ft.)
Drop Condition: **Open**

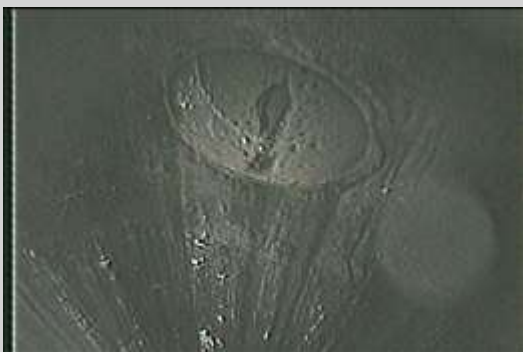
Pipe In @ 8 O'Clock

Pipe Material: **Clay** ☐ Pipe Lined

Infiltration: **None** Pipe Seal Cond: **Unknown**

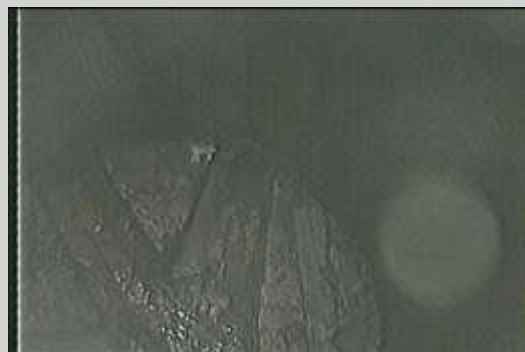
Drop In @ 8 O'Clock

Drop: **Outside** Rod and Bar
Angled: **Yes** Reading: **23.50** (ft.)
Inv Depth: **24.50** (ft.)
Drop Condition: **Open**
